ENGINEERING CASE LIBRARY

ARNOLD WARE'S CRANE ACCIDENT (A)

The boom brake adjusting bolt broke on a crane. The boom fell and injured Mr. Arnold Ware severely. Mr. Ware sued the manufacturer and the operator of the crane. Part A describes the accident and the boom control system on the crane involved in the accident.

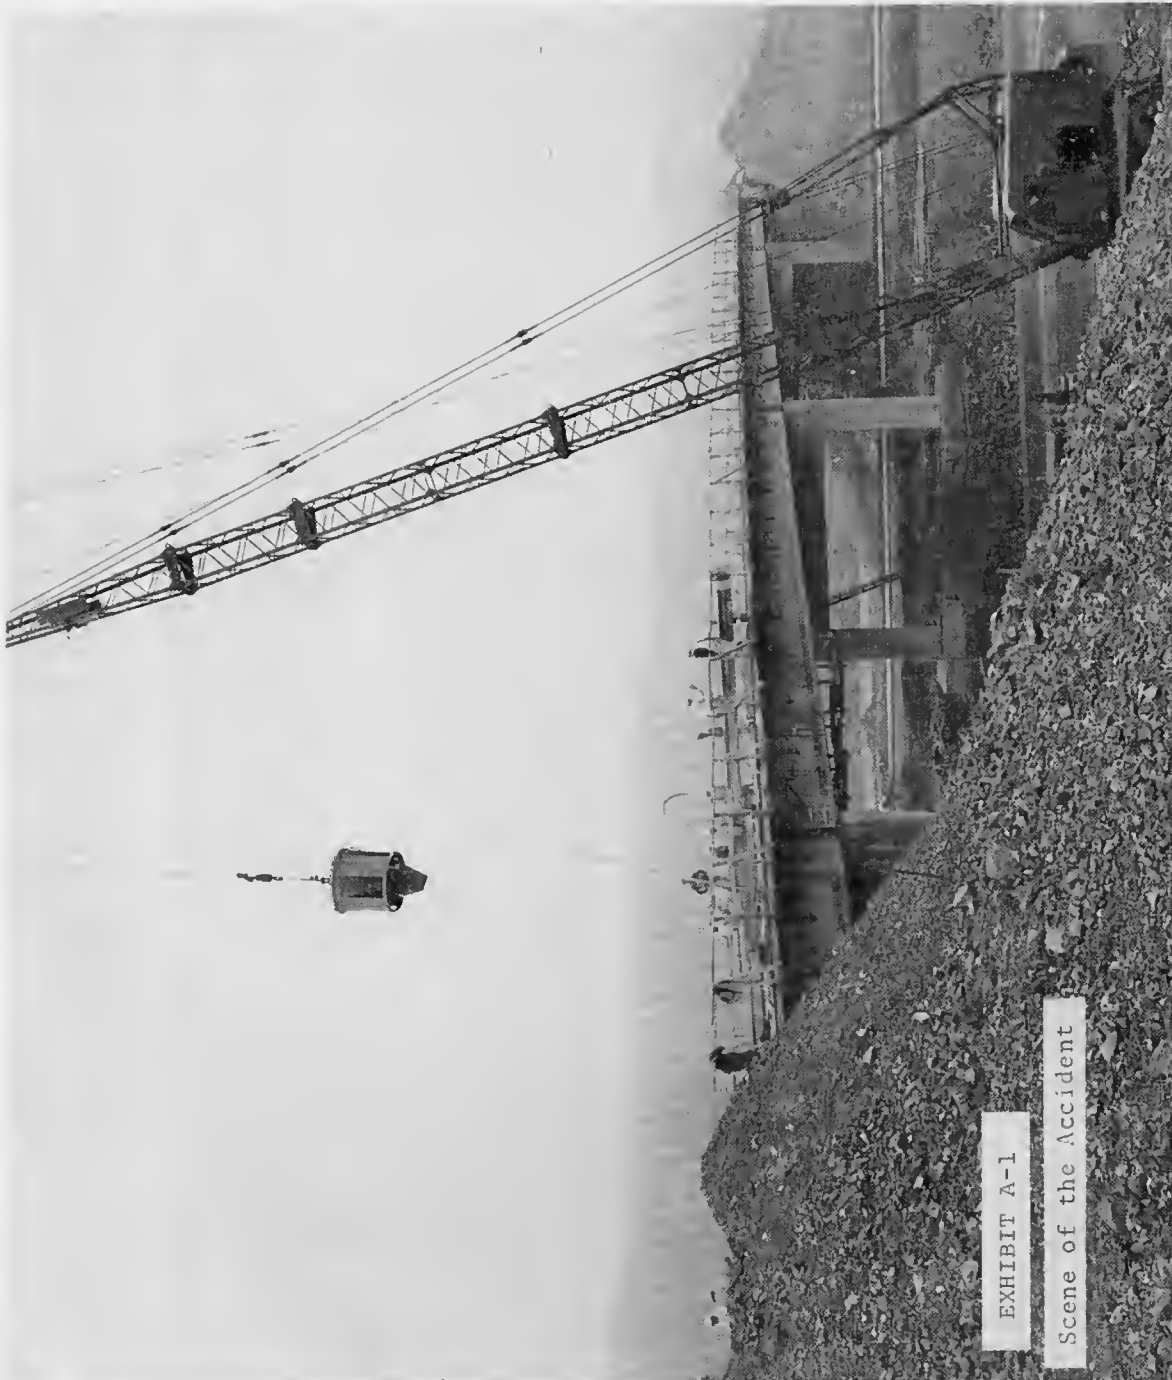
EXHIBIT A-1

Scene of the Accident

On December 11, 1964, the construction workers of the LSK Engineering Company began their morning as usual at the construction site of the bridge at Poway Road and Highway 395 in San Diego, California. At first it appeared that this would be another normal day, a day toward the completion of the bridge. Exhibit A-1 shows the construction site.

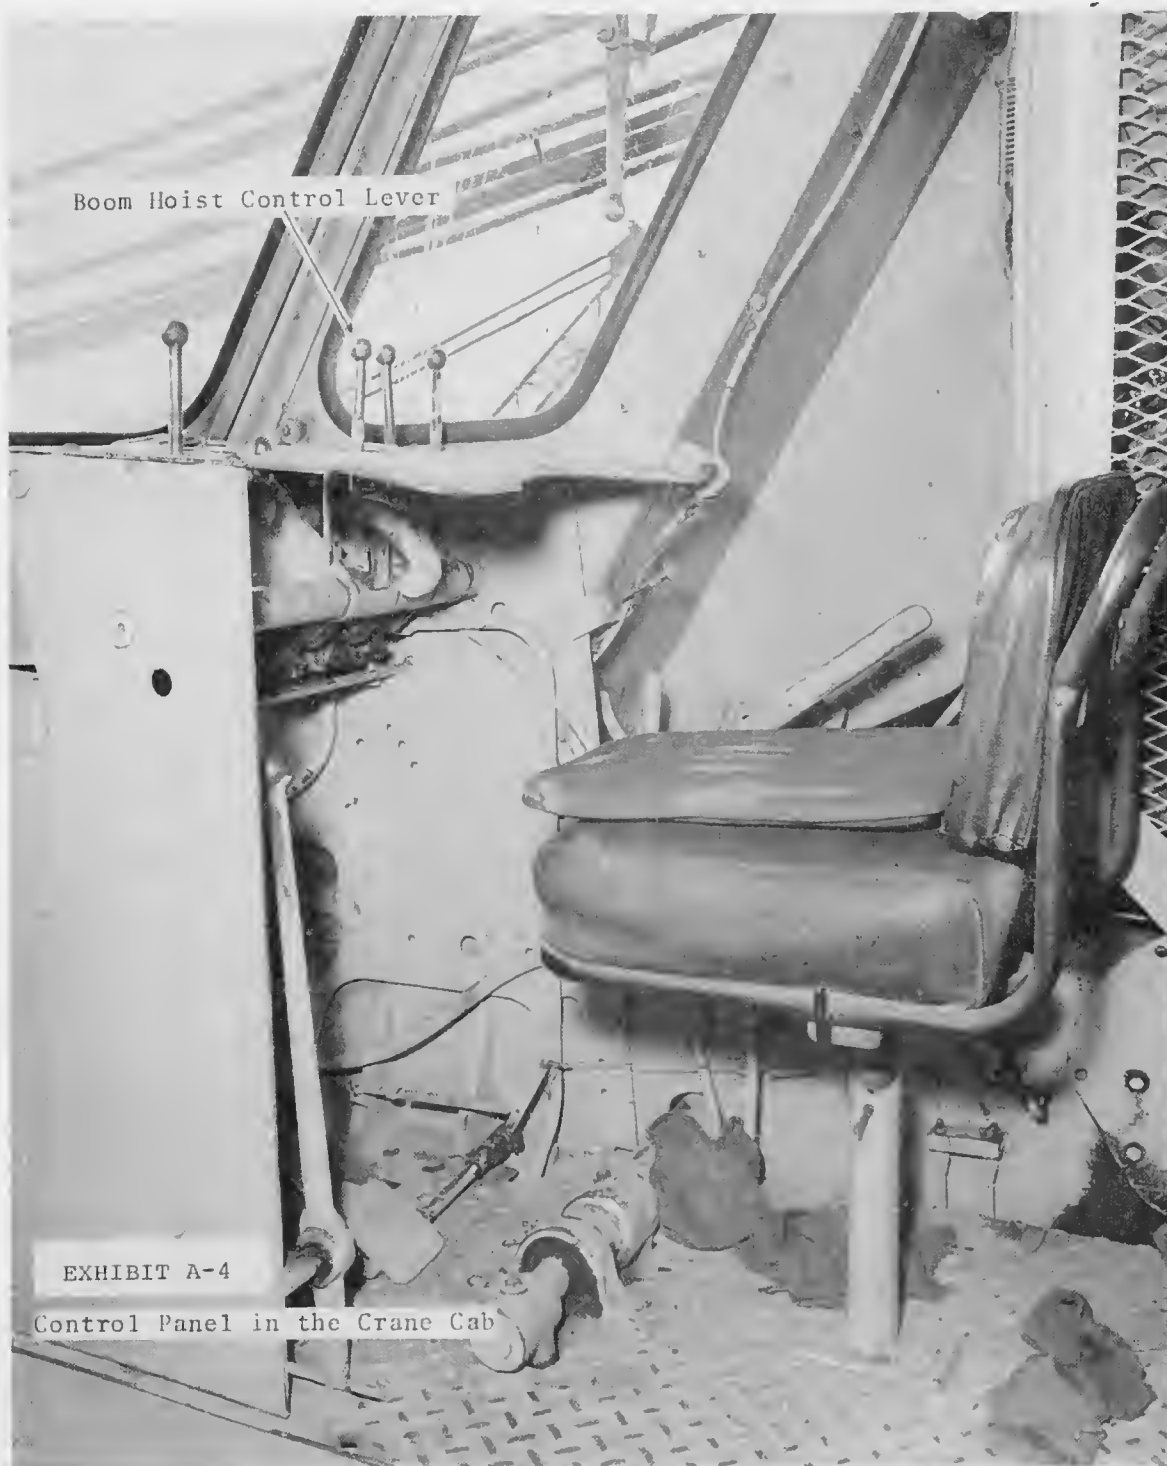
EXHIBIT A-4

Control Panel in the Crane Cab
